FEDERAL HERITAGE BUILDINGS REVIEW OFFICE

BUILDING REPORT 89-205

TITLE: Work Point Barracks, CFB Esquimalt (15 Buildings)  
Canadian Forces Base Esquimalt  
British Columbia

SOURCE: Ian Doull, Architectural History Branch

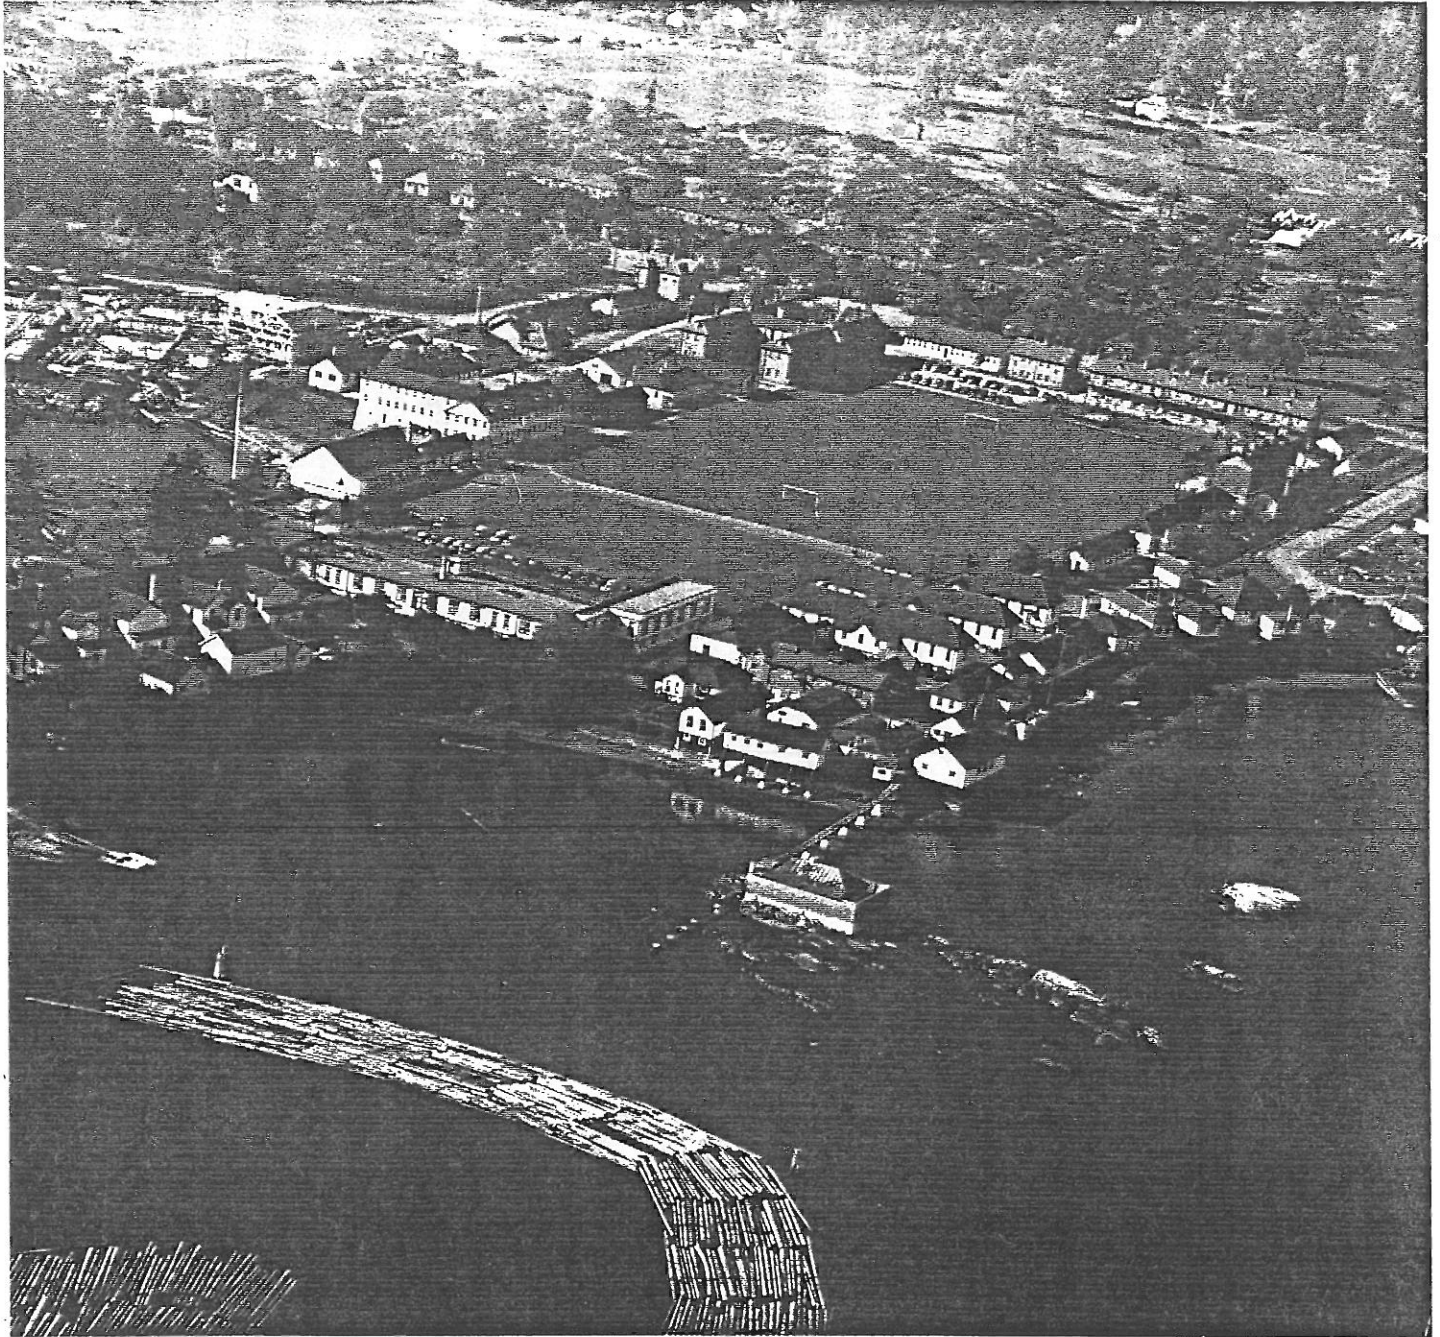
11 Work Point Barracks, looking west, showing former Royal Engineers buildings at centre right (demolished); three Canadian barracks blocks, centre right (one extant, no. 1004); World War II frame buildings 1043, 1045, 1048, under construction, upper left; original parade square and recreation grounds, 1941. (Canadian Forces Photo Unit.)

Building 1001 stands at the gateway to Work Point Barracks, where the principal access point to the site has been located since 1887 (Figures 1, 8, 9). The front (south) elevation faces the roadway across a sidewalk (Figure 2). The east side of the site consists of a large, raised paved area (Figure 10); the opposite (west) side abuts the Work Point boundary fence. The rear of the site descends to water level. Changes include the construction, in two stages, of the rear annex, replacement of the original wooden arched gateway with brick gateposts at the same location, and the demolition in the 1950s of a number of frame structures which stood immediately to the east (see Part I, Figures 11, 12).

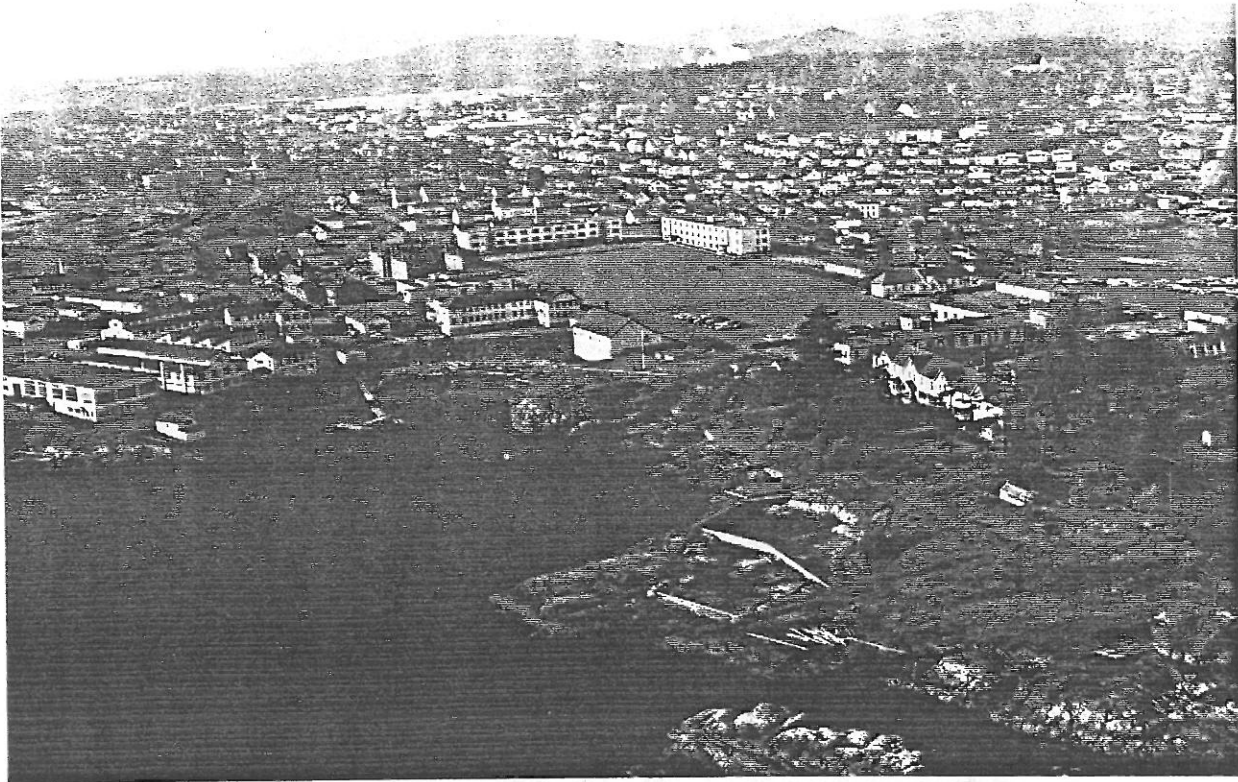
13 Work Point Barracks, looking northwest, 1964. (Canadian Forces Photo Unit.)

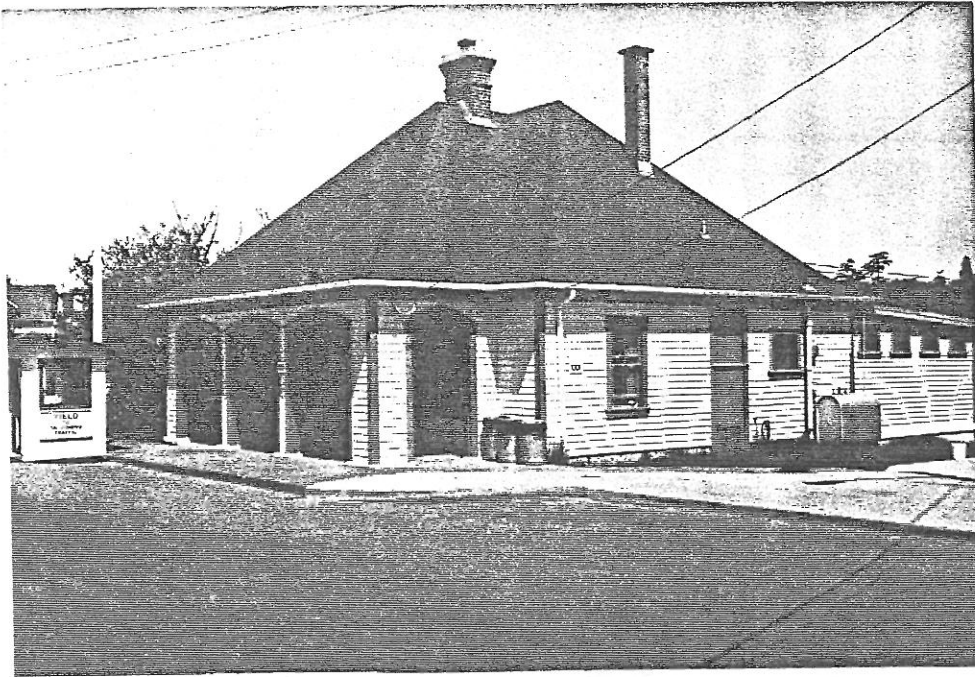
2 Building 1001, main (south) and side (east) elevations. (Ian Doull, AHB, Parks, 1989.)

The guardhouse is a shiplap-clad frame structure with a stone foundation.<sup>6</sup> The interior partitions in the original cell area are of vaulted brick. The building exhibits competent craftsmanship, and remains in good condition.

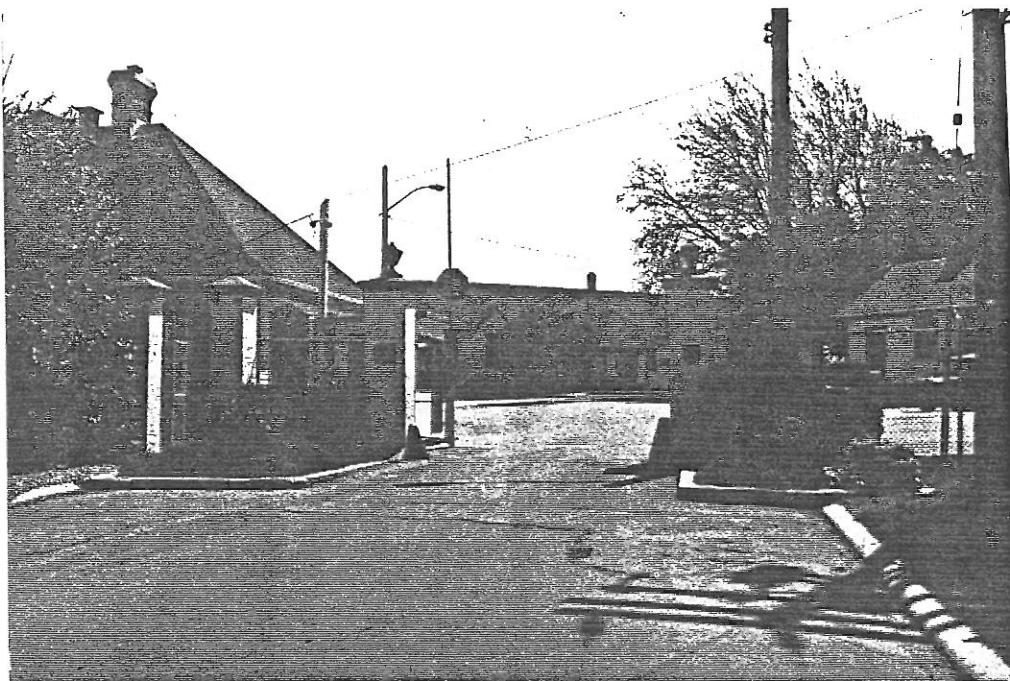
9 Buildings 1001, 1004, 1087 (L-R), looking east through the main gate. (Ian Doull, AHB, Parks, 1989.)

The guardhouse is a prominent component of a loose cluster of three surviving pre-1906 frame buildings (nos. 1001, 1087 and 1004) situated near the main gate (Figure 9). The guardhouse stands out because of its distinctive design and proportions.

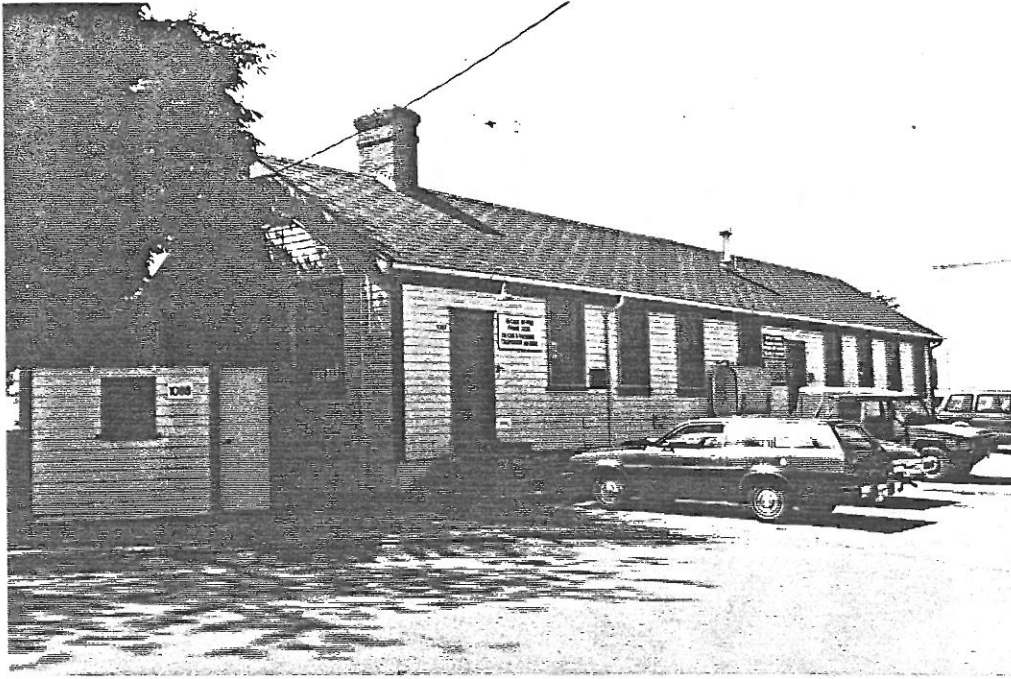
2 Building 1087, main (north) elevation; the weigh station, building no. 1088, stands at left. (Ian Doull, AHB, Parks, 1989.)

Building 1087 is a simple but attractive one-storey, rectangular, end-gabled structure. The regular fenestration patterns on the long (north and south) elevations contribute to a balanced design (Figures 2, 3). The main (north) elevation, which displays a slightly exposed foundation, contains the two entrance doors. No information has been found regarding the original plan. The current layout consists of a series of rooms of various sizes, oriented at a cross-axis to the building and connected by a longitudinal corridor which runs along the north wall (Figure 4). The divisions probably reflect the sum of alterations made to accommodate a succession of building occupants in recent years. The building is a shiplap-clad frame structure, resting on a brick and concrete base. It exhibits competent craftsmanship, and remains in good condition. It was designed by the Royal Engineers.<sup>2</sup>

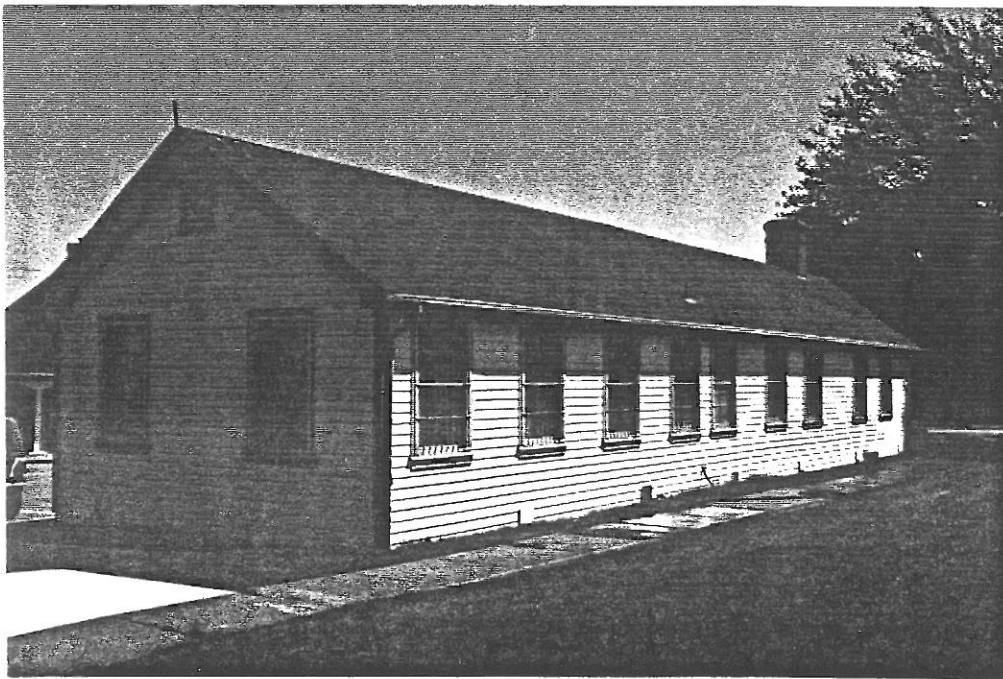
3 Building 1087, rear (south) and end (west) elevations. (Ian Doull, AHB, Parks, 1989.)

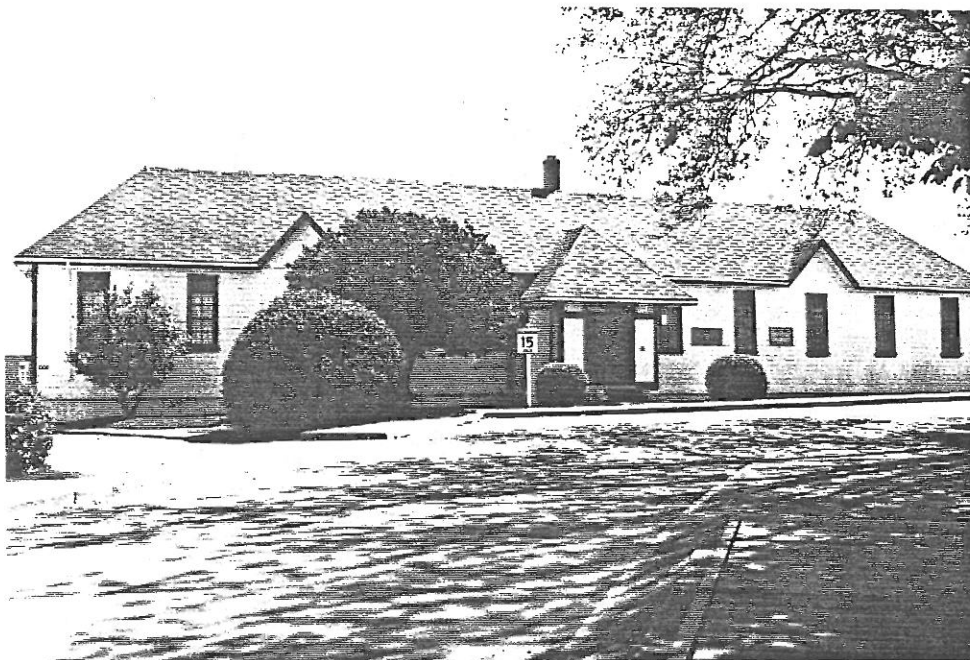
2 Building 1004, main (west) elevation.  
(Ian Doull, AHB, Parks, 1989.)

Building 1004 is a simple but attractive one-storey rectangular structure, with central projections at the front and rear (Figures 2, 3). The hipped roof is broken by two gables on the main (west) elevation, and by a hipped roof extension over the central projecting entrance vestibule. The latter features brackets, a double-leaf door, and a semi-circular transom (Figure 4). The regular fenestration pattern on both the front

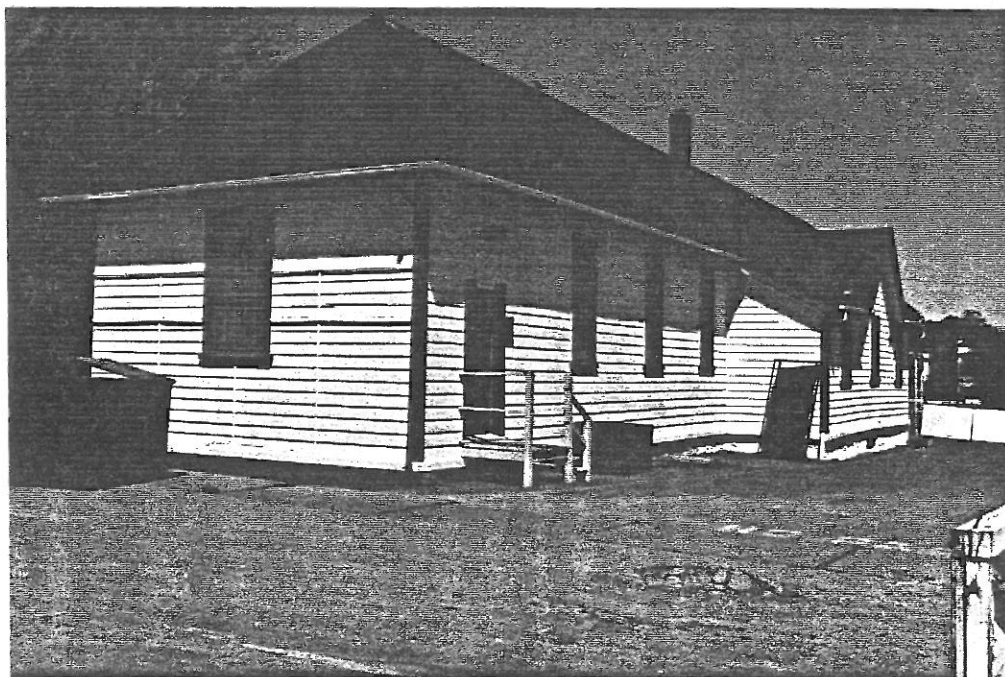
3 Building 1004, rear (east) and end (south)  
elevations. (Ian Doull, AHB, Parks, 1989.)

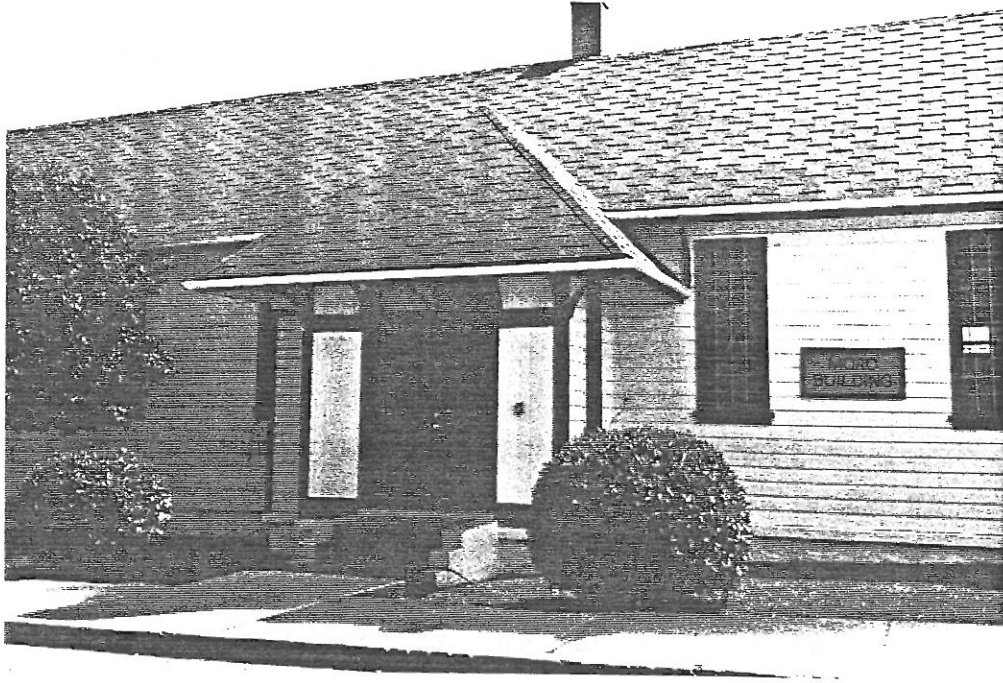
4 Building 1004, main entrance. (Ian Doull, AHB, Parks, 1989.)

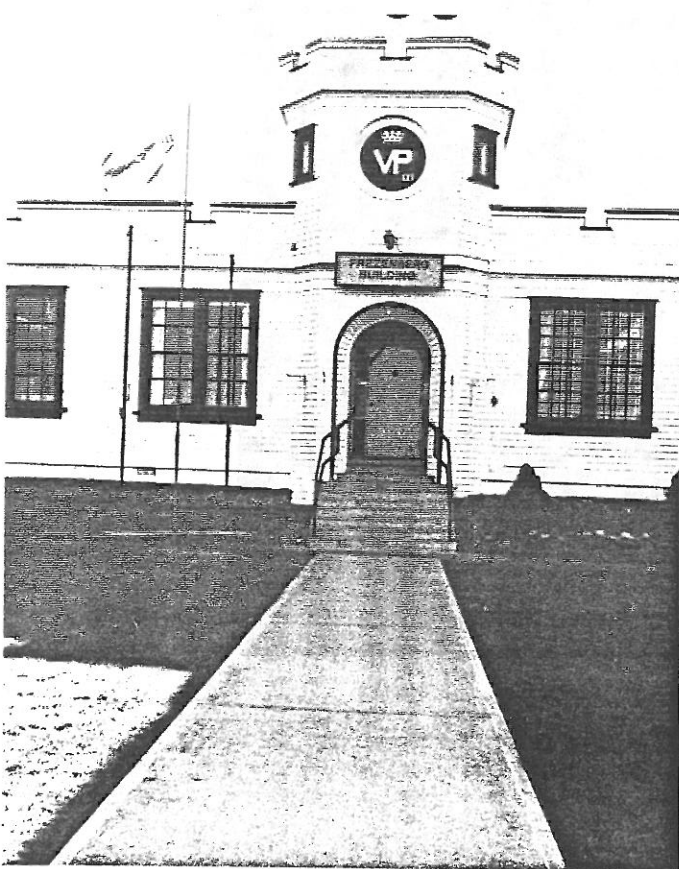
3 Building 1020, detail of  
main entrance and tower.  
(Ian Doull, AHB, Parks,  
1989.)

Building 1020 displays superior craftsmanship in the execution of the carpentry on all exterior components. The building is a shiplap-clad frame structure. The foundation of the original section is concrete-topped rubble; the 1940s wing stands on a concrete foundation. The building is in good condition structurally, although the interior wall and partition material is in need of upgrading or replacement. The original paneling and fittings, including picture rails, remain in many areas.

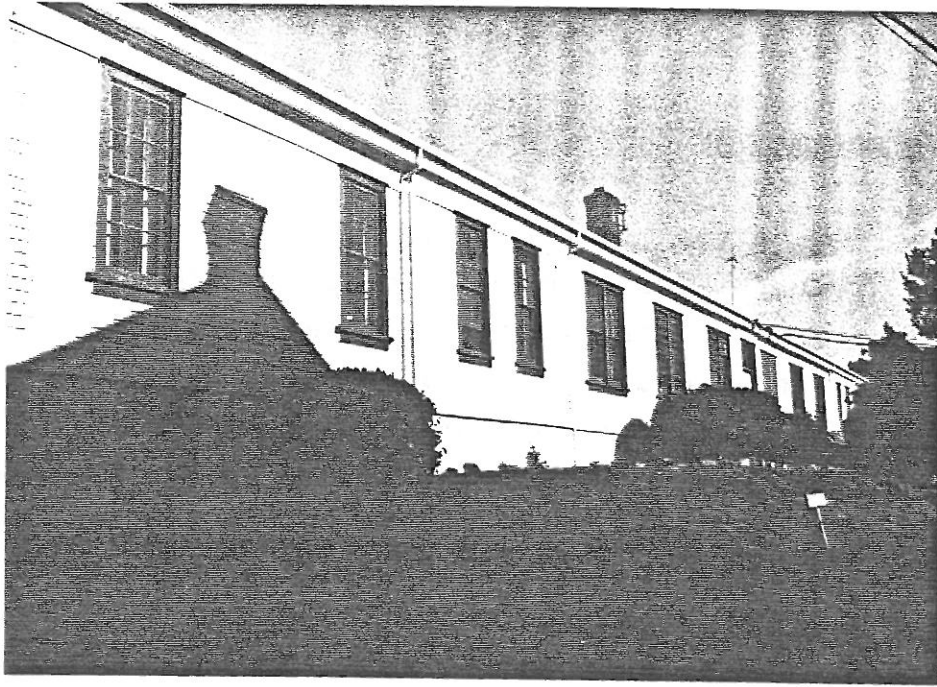
9 Building 1020, rear (east) elevation.  
(Ian Doull, AHB, Parks, 1989.)

around the end (south) and rear (east) of the building, where it is contained within low stone retaining walls (Figures 8, 9). The northernmost site area contains a driveway. The site merges in features and topography with that of the officers' mess, building 1027, situated immediately to the east; both feature carefully tended landscaping, indicative of high-level use and/or occupants (Figure 8). Changes include the replacement of a hedge by curbstones along the western boundary, and the replacement of the former officers' stables, once situated on the northern boundary, by a new building (no. 1093, see Figure 1) completed in 1989.

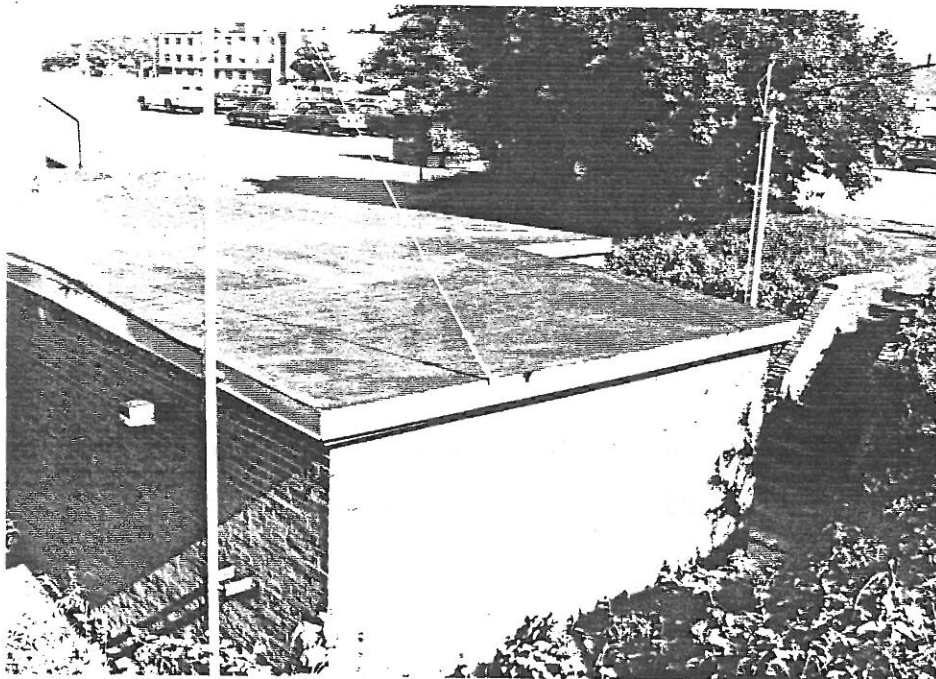
3 Building 1030, rear (east) elevation,  
showing stairs descending from ground  
level. (Ian Doull, AHB, Parks, 1989.)

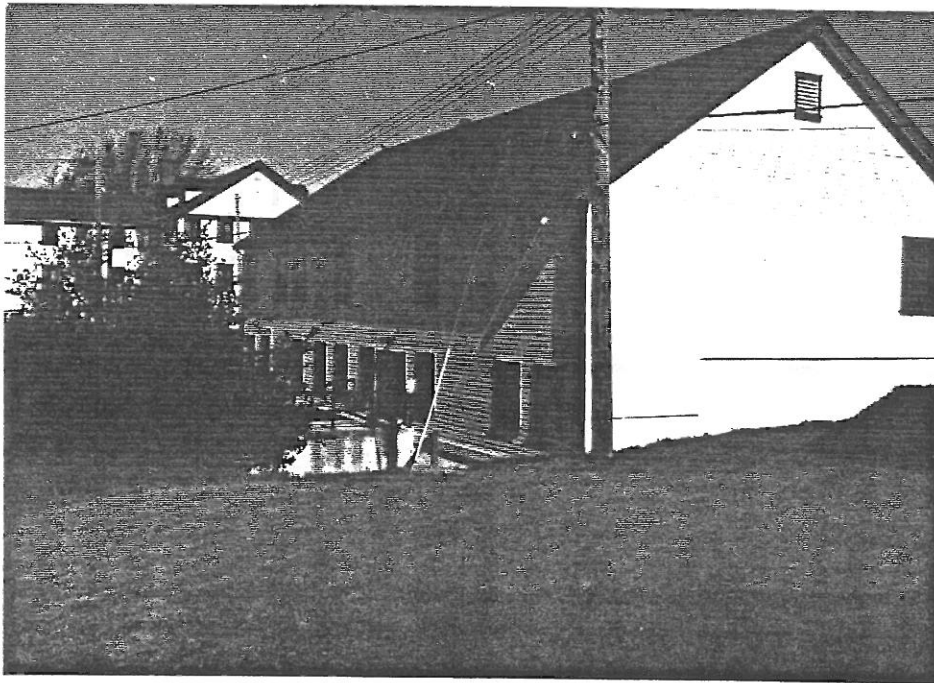
3 Building 1031, rear (south) and end (east) elevations; building 1033 is visible at left. (Ian Doull, AHB, Parks, 1989.)

Building 1031 is a simple but attractive and well-proportioned one-storey structure. The end-gabled roof extends outward over a raised loading dock on the main (north) elevation to form an open, bracketed verandah (Figure 2). The foundation is fully exposed at the rear, where a retaining wall has subsequently been constructed (Figure 3). The central areas of both the full basement and ground storey consist of open storage spaces, with partitioned areas situated at the eastern and western ends (Figure 4). Building 1031 is a shiplap-clad frame structure resting on a concrete foundation. It exhibits competent craftsmanship, and is in good condition. Its designer has not been determined.

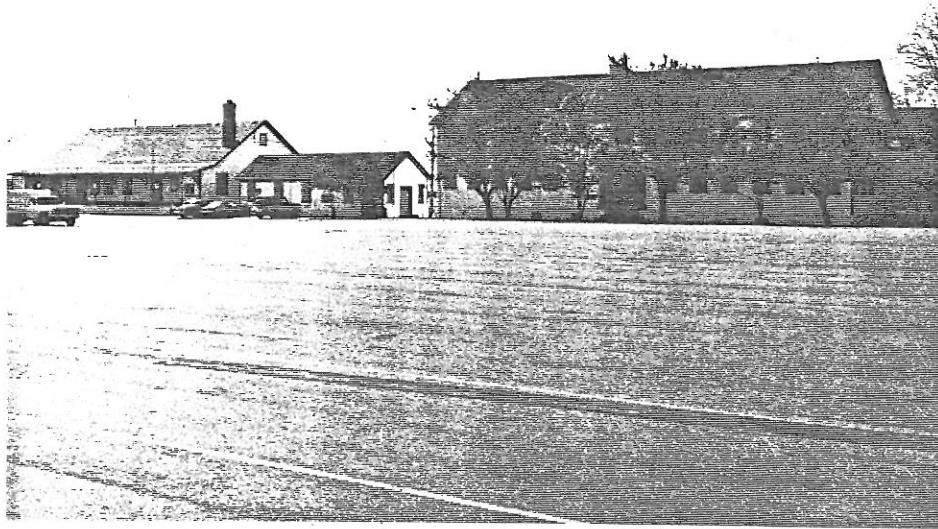
5 Buildings 1031, 1032, 1033 (L-R).  
(Ian Doull, AHB, Parks, 1989.)

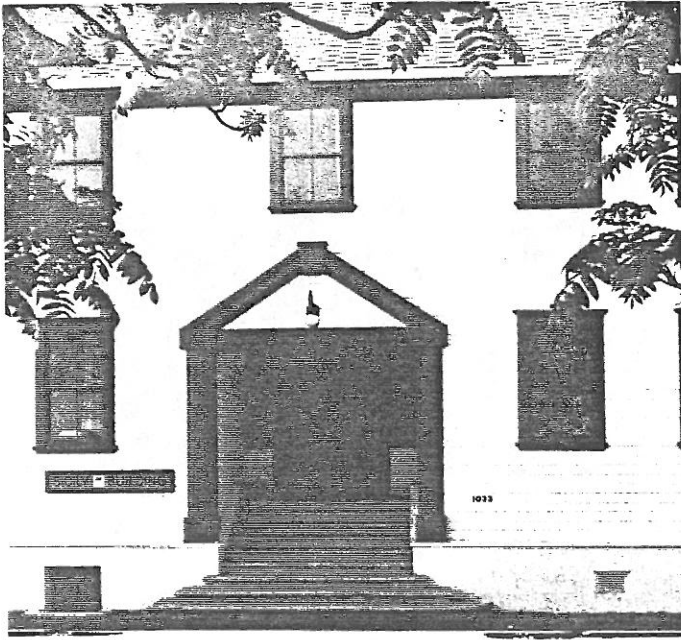
4 Building 1033, main entrance detail. (Ian Doull, AHB, Parks, 1989.)

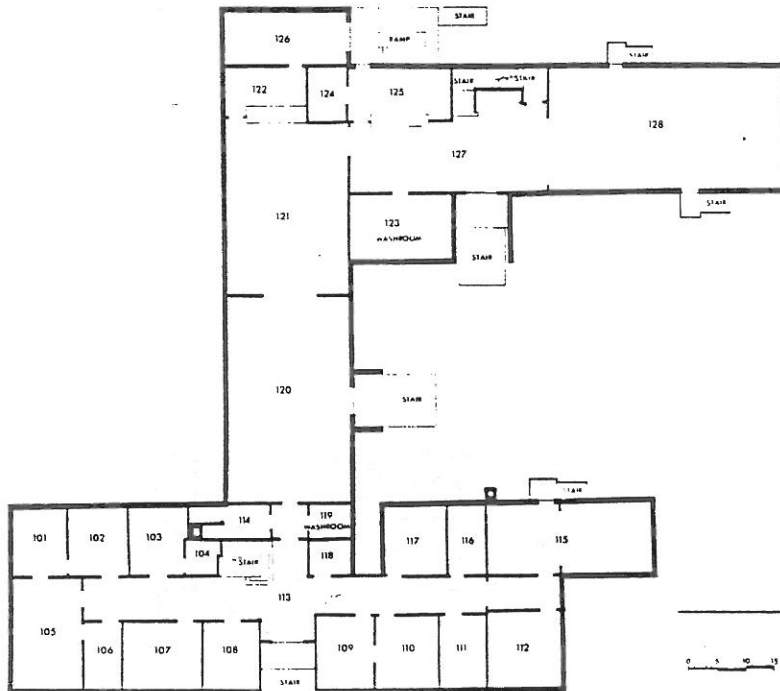
FIRST FLOOR

- 8 Building 1033, basement and ground-floor plans; underlined basement room numbers indicate crawl spaces. (Stevenson Kellogg Report, Vol. 3, pp. 50, 53.)

The original floor plans are uncertain, but it is assumed that some alterations have been made. The ground storey of the original section is efficiently organized by a longitudinal centre hall, crossed by a second corridor which provides access from the main entrance through to the rear addition (Figure 8). The latter contains a series of large, interconnected rooms. A number of annexes are situated on the interior (courtyard) elevations of the addition, and two other entrances are located at the extreme south (rear) of the building. The same general plan is found throughout the second storey, with an exit door situated on each of the three wings (Figure 9). The building contains a full basement, which consists of a combination of storage rooms and crawl spaces (Figure 8).

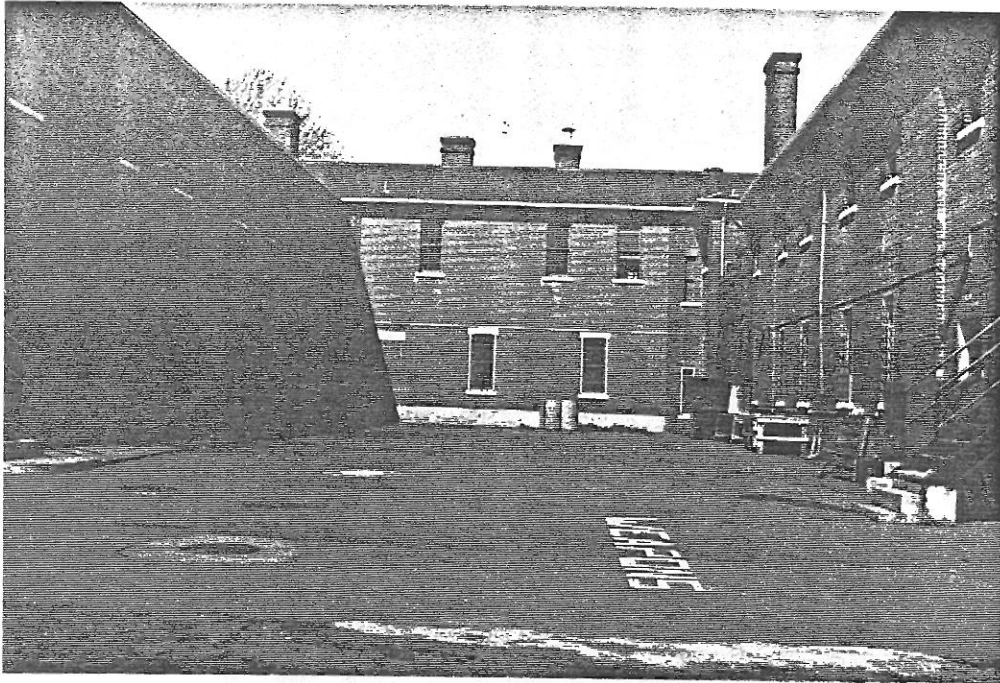
4 Building 1075, connecting wing, looking west.  
(Ian Doull, AHB, Parks, 1989.)

Building 1075 is a distinctive, well-balanced, and attractive two-storey "H"-shaped structure, with gable roofs. It was built as two adjacent free-standing buildings;<sup>4</sup> the connecting wing features a lighter-coloured brick. Each long (north and south) elevation contains a central, stepped projection which probably held the original stairwells (Figures 2-4). The building displays the same design elements found on other British-built brick garrison buildings at Work Point and at Signal Hill. These include corner pilasters, a continuous rounded-brick plinth, and

prominent corbelled chimneys, the shafts of which project in relief from the exterior walls. The slightly raised concrete foundation creates a contrasting base (Figures 4-6). The nine-over-nine and six-over-six sashes on the tall windows appear to be original.

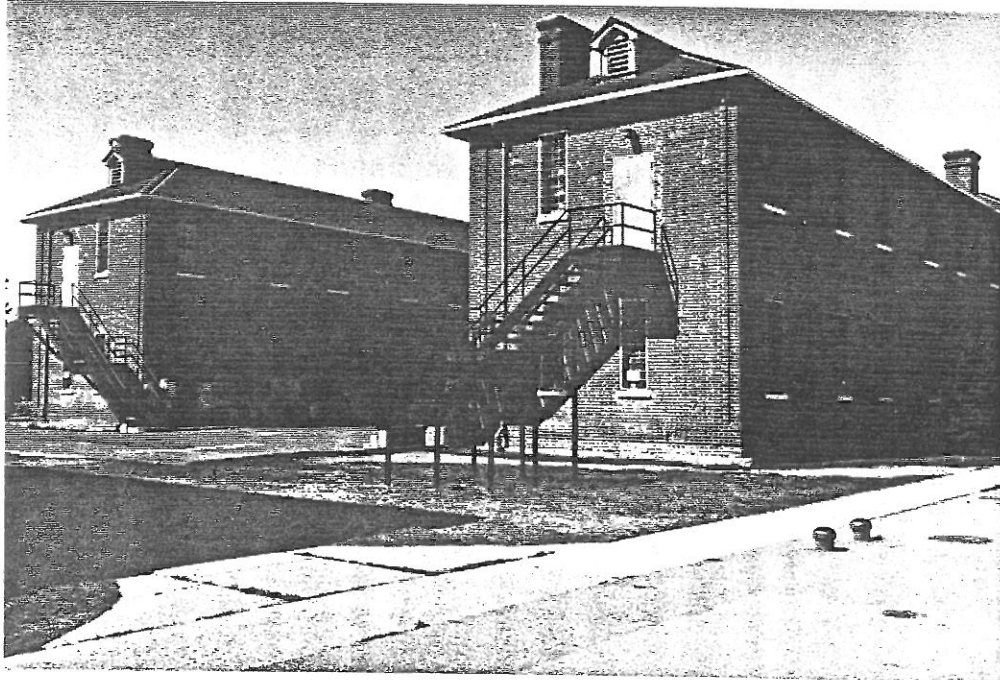
5 Building 1075, end (east) elevations.  
(Ian Doull, AHB, Parks, 1989.)

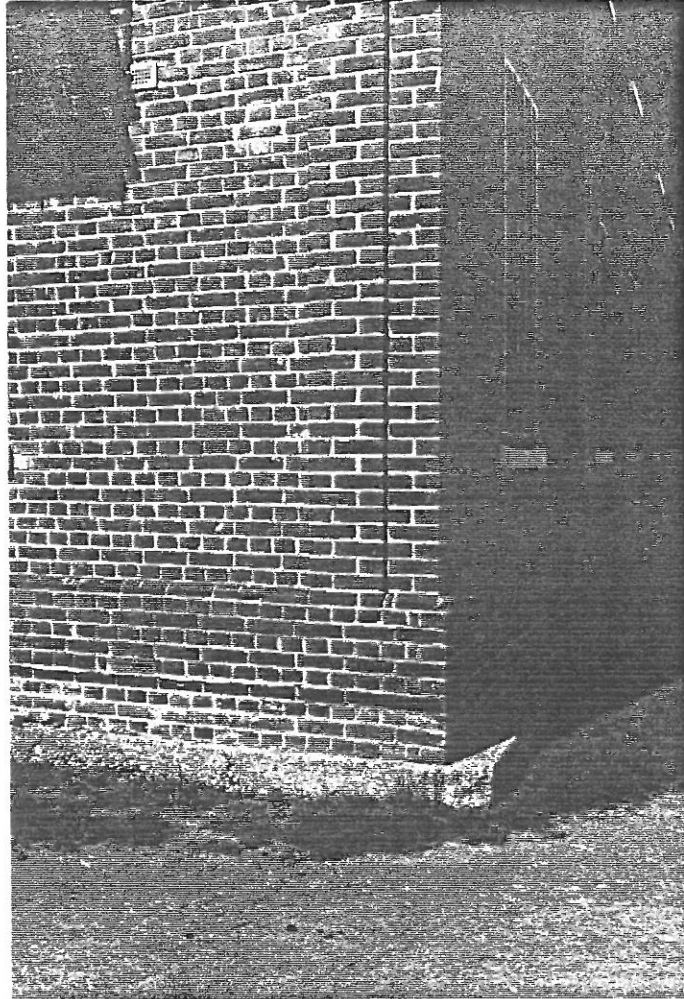
6 Building 1075, corner detail.  
(Ian Doull, AHB, Parks, 1989.)

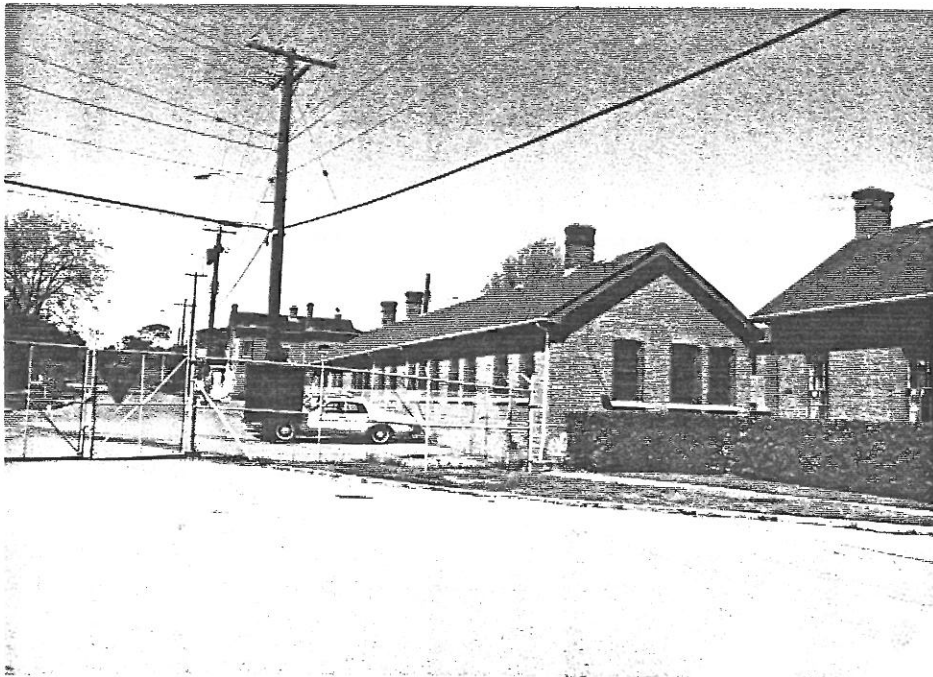
3 Building 1070, rear (south) and end (east)  
elevations; building no. 1068 is visible at  
left, no. 1071 stands at right.  
(Edward Mills, AHB, Parks, 1989.)

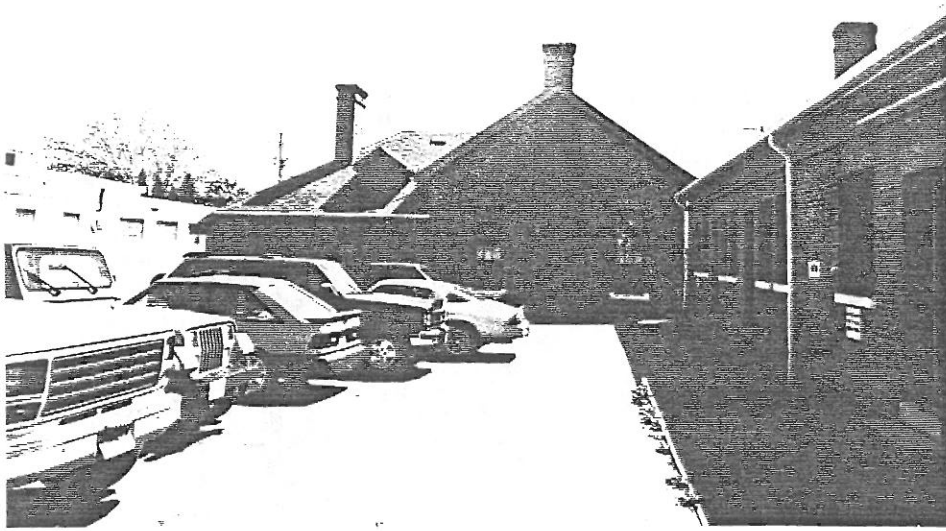
4 Building 1071, west elevation; building 1070 stands at right. (Edward Mills, AHB, Parks, 1989.)
